Punctuality and maintenance

Infrastructure and rolling stock

Trafikverket Swedish transport administration

Rikard Granström, PhD Project manager Maintenance Southern iron ore line and Haparanda line

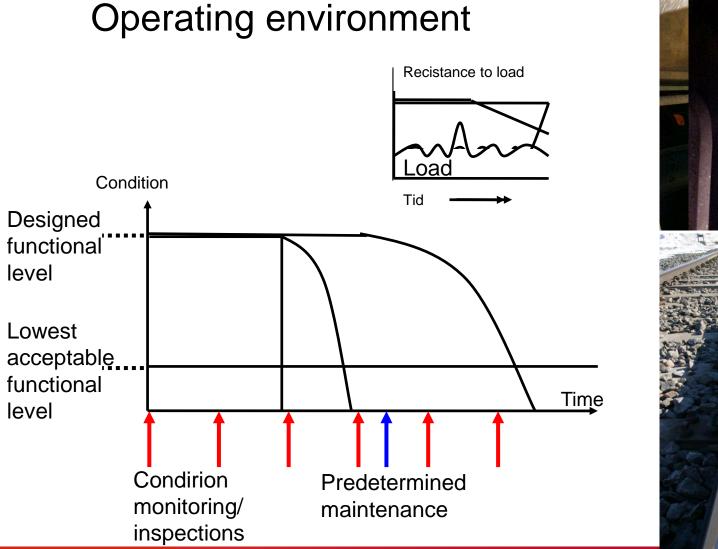
support for maintenance planning and maintenance execution (remaining time to fault)

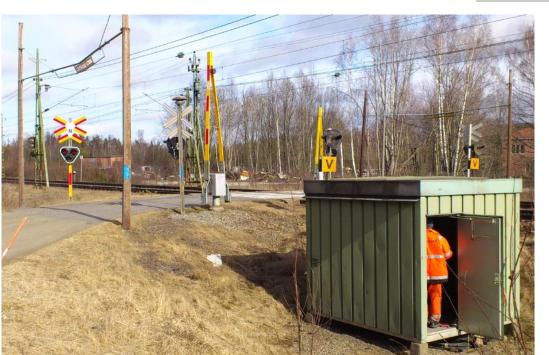
Results from implementation of results from FMECA on level crossings in 2012

All faults

Antal av Felrap	oport Id	
Year	" T	Summa
Tear	2008	90
	2009	95
	2010	97
	2011	75
	2012	50
	2013	50
	2014	38
	2015	44
	2016	48
Totalsumma		587
